**An Independent Check of the Performance of
Two M2208 Fatigue Meters**

Air Vehicles Division
Defence Science and Technology Organisation

DSTO-TN-1031

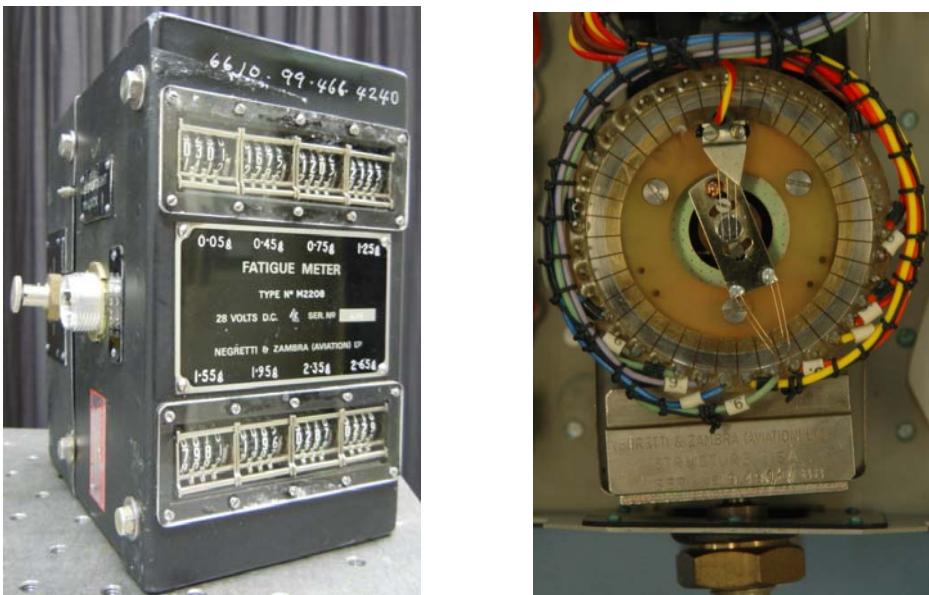
Figure 1 Photo of one of the M2208 meters tested (left), and type 15A accelerometer (right)

documentation⁹ states that the post Mod Z200¹⁰ M2208 is equipped with a type 15-1026 accelerometer, of the basic type M2221. Visual inspection of meter with serial number A144 revealed it was equipped with a Type 15A accelerometer.

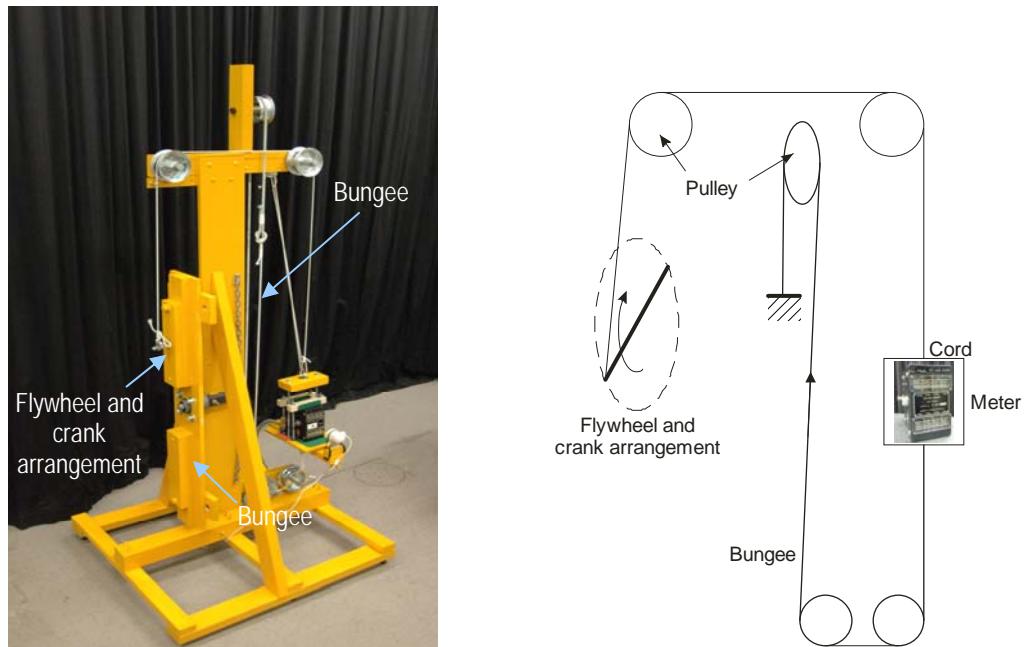
Figure 4 Photograph (left) and schematic (right) of the experimental Long Stroke test rig used ($<<7$ Hz, >2.65 g, <45 g/s)

The specially designed and manufactured Long Stroke rig, employing a large rotary inertia mechanism to limit rate of change of acceleration and a long vertical linear travel to achieve the maximum desired acceleration while accommodating the maximum permitted rate of change of acceleration. An image and a schematic of the mechanism of the rig in Figure 4 shows the effective flywheel and crank on the left of each image, with a system of pulleys and cords to translate rotary to linear motion, and the return bungee is to the right of the centre column. A series of runs were performed with the crank at various initial angles producing a set of semi random excitation levels.

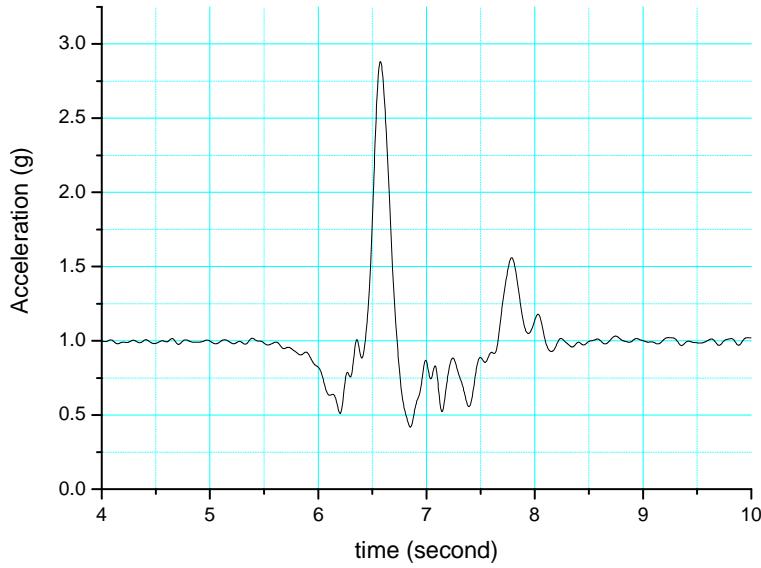
Figure 5 shows a typical acceleration trace produced by the Long Stroke rig and Figure 6 shows the rate of change of acceleration is well within the 45 g/s instrument specification.

Figure 5 Typical trace of g produced by Long Stroke rig

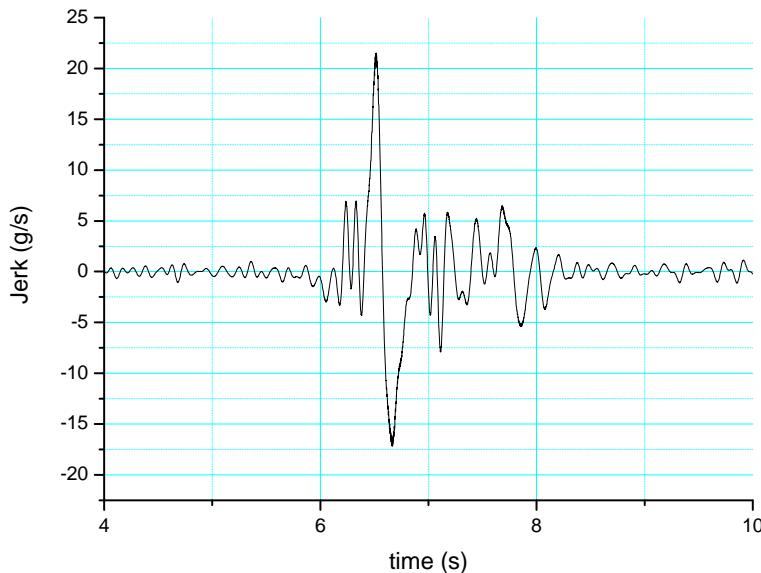
Figure 6 Typical trace of g/s produced by Long Stroke rig

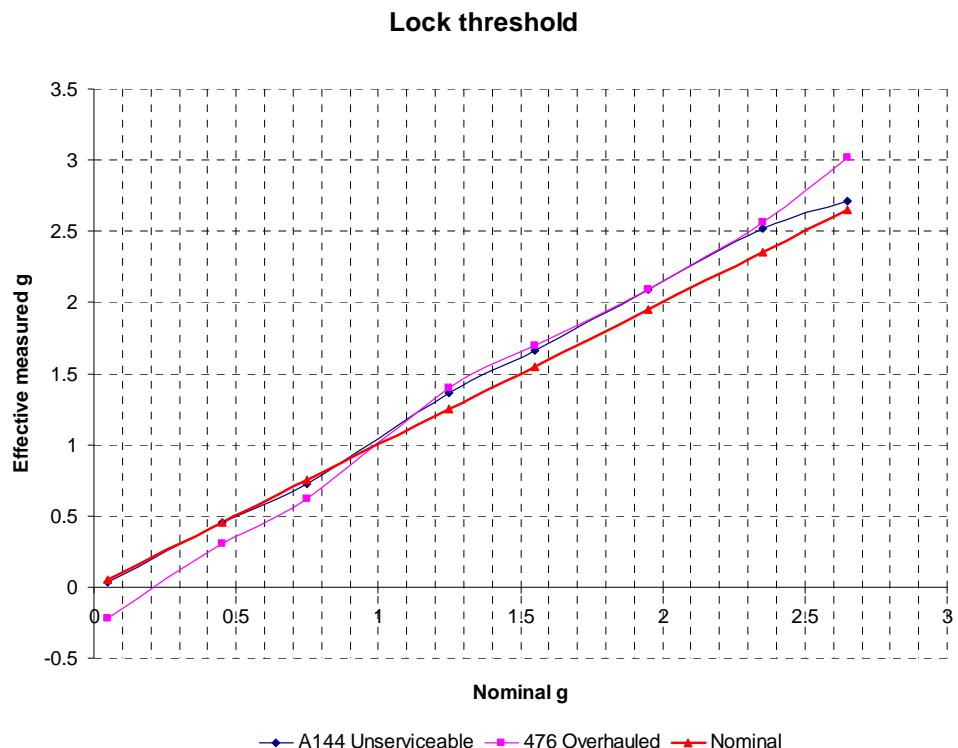
Both meters appeared to be free from external damage and superficially operating in the correct manner. The measured threshold values are tabulated in Table 1 and displayed graphically in Figure 7. When calculating the deviation (or error) in Table 1, two values were calculated (1) absolute deviation relative to 0 g and (2) the relative deviation where the straight and level flight (1 g) condition was taken as the reference condition. Thus the percentage deviation was calculated and displayed graphically in Figure 8, which illustrates the symmetry in the G3 and G4 deviations.

It is interesting to note that this method of testing indicated the recently overhauled instrument had a larger discrepancy from the nominal threshold values for all counters. However, as the deviation on the G3 and G4 counters was of a similar magnitude for the overhauled instrument, it may be expected to perform considerably better on a G4/G3 test than the nominally unserviceable meter where G4 was high but G3 was fairly close to ideal value.

Figure 7 Measured lock threshold levels

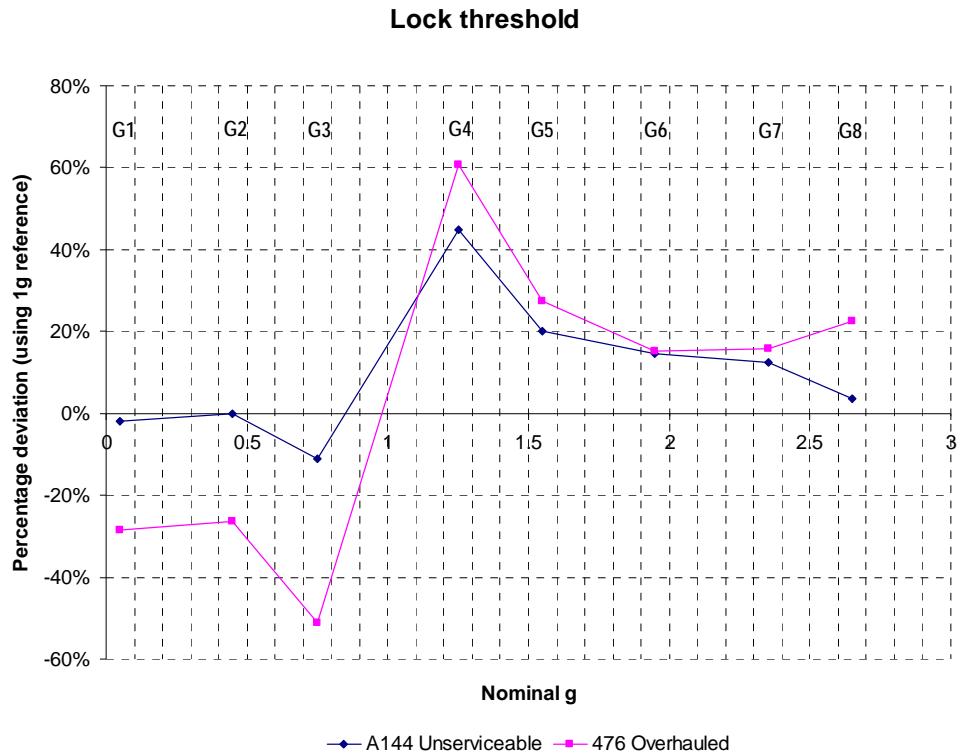
Figure 8 Percentage deviation (using 1 g as the reference)

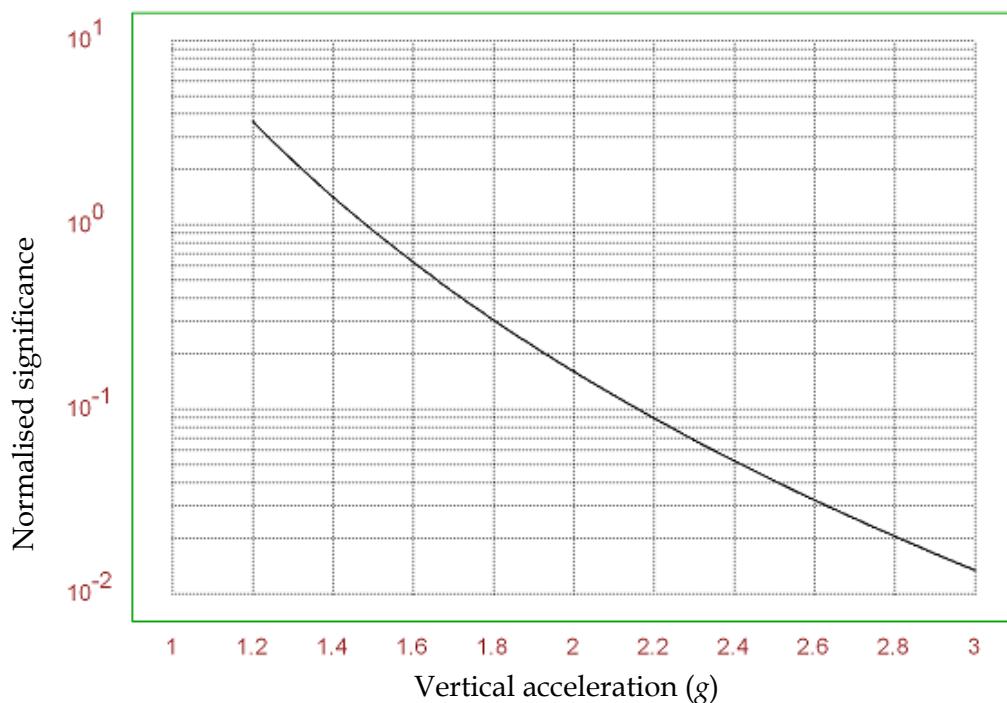
Figure 14 Normalised significance of peaks (derived from Nz exceedances curve and life consumption curves for 7075 aluminium alloy)

Comparing the ideal and measured threshold values indicates the “unserviceable” meters readings (i.e. where the meter is actually measuring 1.36 g compared to expected 1.25 g) would indicate a life consumption about 30% less than that from an ideal meter, while the recently “Overhauled” unit (i.e. where the meter is actually measuring 1.4 g compared to expected 1.25 g) would lead to a reduction of about 40% from that measured using an ideal unit. Consequently, if the meter readings were used to estimate life consumption, then the errors observed in both the unserviceable and the overhauled meters would result in an unconservative estimate of fatigue life.

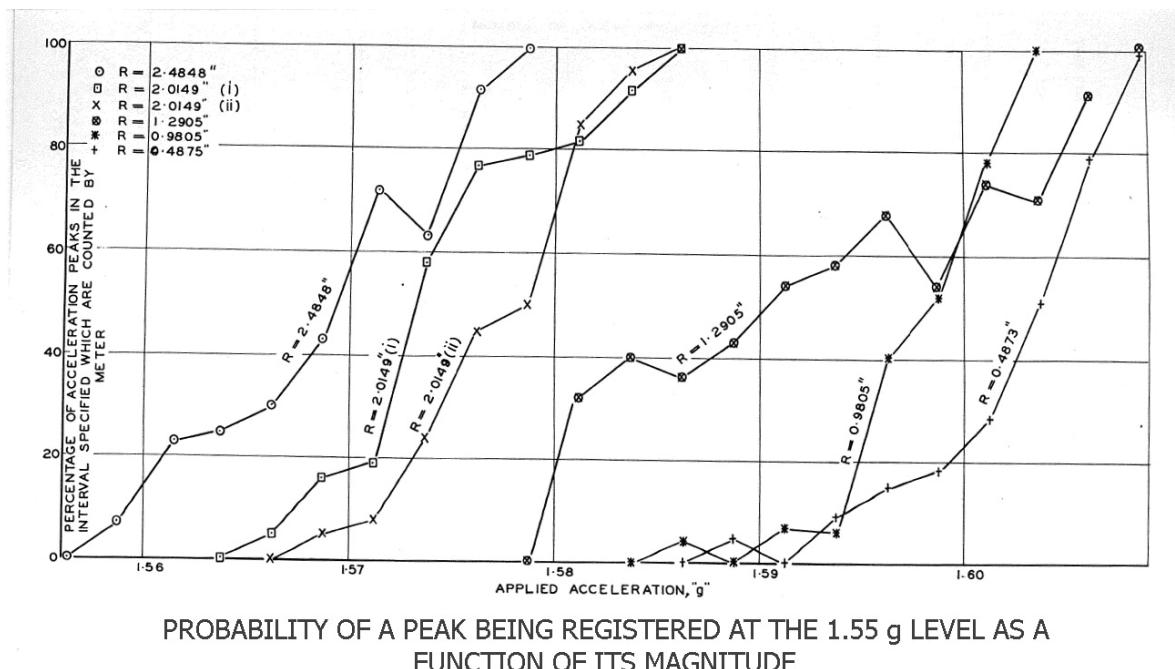
Appendix B Figure 2 from reference [5]

It is reasonable to assume that the loading rate achieved during this type of test is substantially lower than that nominally experienced in flight situations. This effect was previously observed by Nilson [5] when testing a different model fatigue meter (Appendix B refers to Figure 2 from reference [5]).

Note: Calibration was achieved here by a vertical sinusoidally oscillating table driven by a crank, with radius R (in inches), and connecting rod. For a given g level, higher rates of g are achieved using a smaller R .
